Part 11 Airworthiness Information

Leaflet 11-1 Chipmunk Spinning and Aerobatics

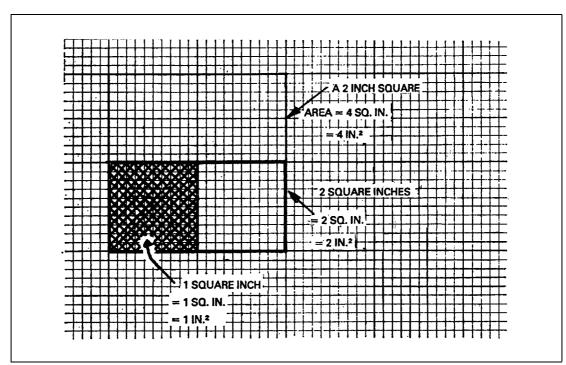
- 3.6 Figure 1 illustrates the unit of area of one square inch, or 1 in² (cross-hatched). An area of two square inches is shown, occupying twice the area. A two inch square, i.e. a square of sides 2 inches, clearly occupies four times the area or 4 in².

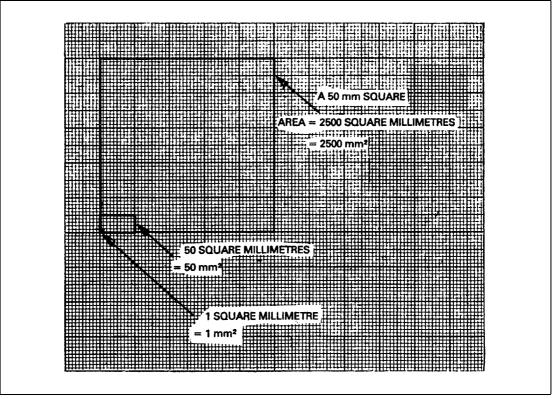
3.7 Figure 2 similarly illustrates the unit of area of one square millimetre, or 1 mm², and as an example, an area of 50 square millimetres (i.e. 50 mm², in that case a rectangle 5 mm by 10 mm). Once again this is quite different from the area of a 50 mm square, which is 50 times greater.

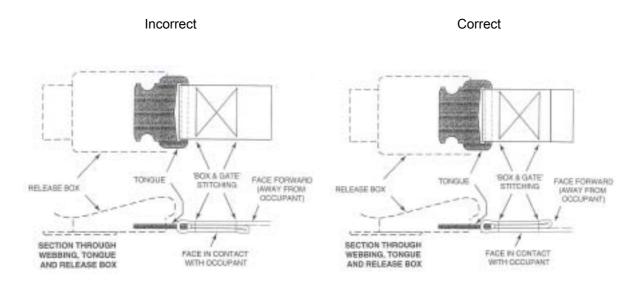
- **4** Where the Original Equipment Manufacturer (OEM) provides instructions on the installation of their seat belts / harnesses, these should be followed.
- **5** In the absence of OEM instructions, the CAA would advise using the following best practice.
- 5.1 During routine maintenance and inspection by owners, the Popular Flying Association, the British Microlight Aircraft Association, licensed aircraft maintenance engineers and approved maintenance organisations, the joint between harness webbing and metal components (release boxes, tongues and adjusters) should be checked.
- 5.2 Where the webbing reversed overlapped and stitched sections are orientated towards the body, if practical, the joint orientation should be reversed.

excluded from this notice. Care should be taken to ensure that any overlapped joints do fall behind the body on all occasions allowing for all reasonable variations of adjustment of the seat belt to accommodate a full range of adult human body height and girth.
